Protecting Airline Personnel from Falls

by William L. Rankin, Ph.D., Boeing Technical Fellow, Maintenance Human Factors, and William R. Carlyon, Program Management Specialist, Environment, Health and Safety

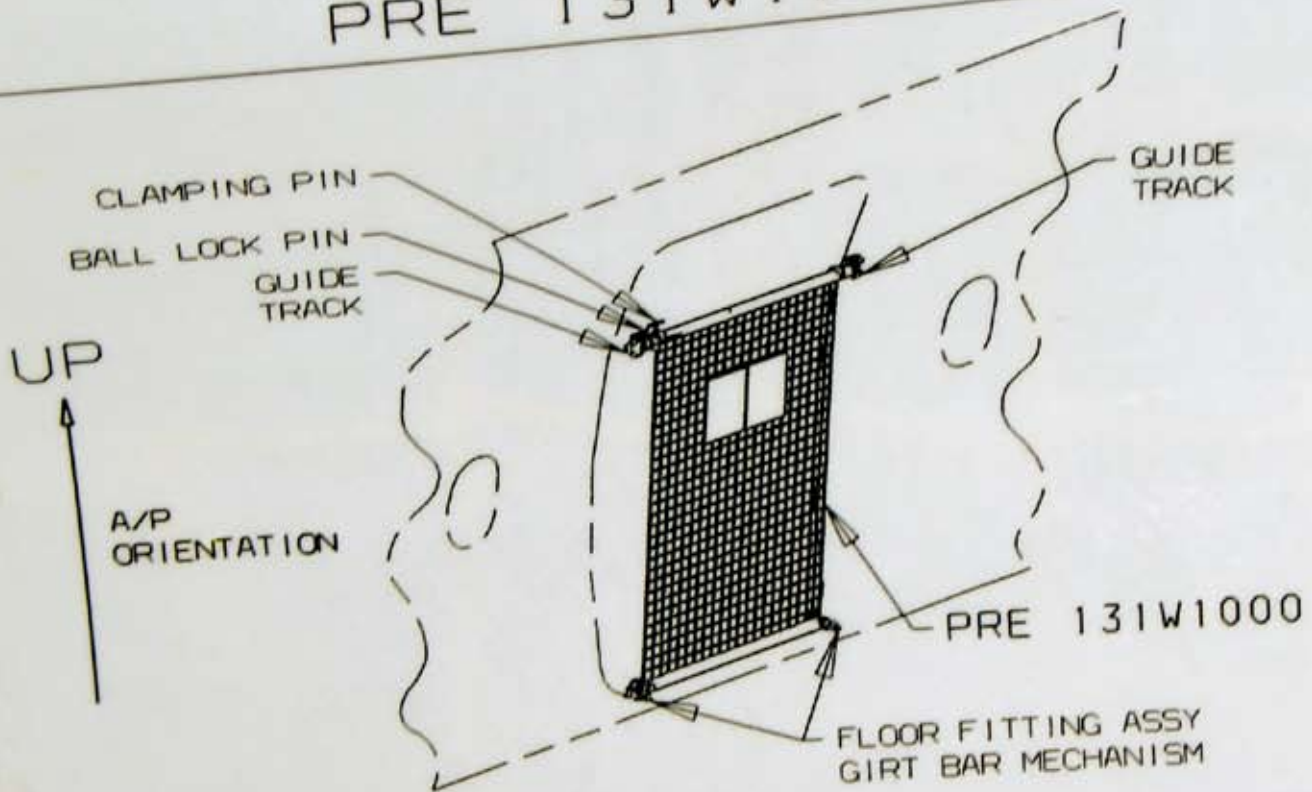
INSTRUCTIONS FOR USE OF PRE 131W1000

1. LOCATE BOTTOM OF PRE 131W1000 (TUBE WITHOUT CLAMPING PIN) AND POSITION SECURELY IN THE (2) FLOOR FITTING ASSYS-GIRT BAR MECHANISM.
2. COMPRESS LEFT END OF THE TOP TUBE OF PRE 131W1000 UNTIL THE TUBE CAN BE POSITIONED BETWEEN THE (2) GUIDE TRACKS. RELEASE TO FULL EXTENSION. ENSURE THAT THE ENDS ARE LOCATED IN THE GUIDE TRACKS. TIGHTEN CLAMPING PIN AND PLUG THE BALL LOCK PIN TO SECURE POSITION.

NOTE: IF DESIRED TO HOLD NETTING TIGHT, A WIRE TIE THAT ATTACHES THE NETTING SIDE TO AVAILABLE AIRPLANE FRAME STRUCTURE IS ACCEPTABLE.

THIS SIDE FACES INBD

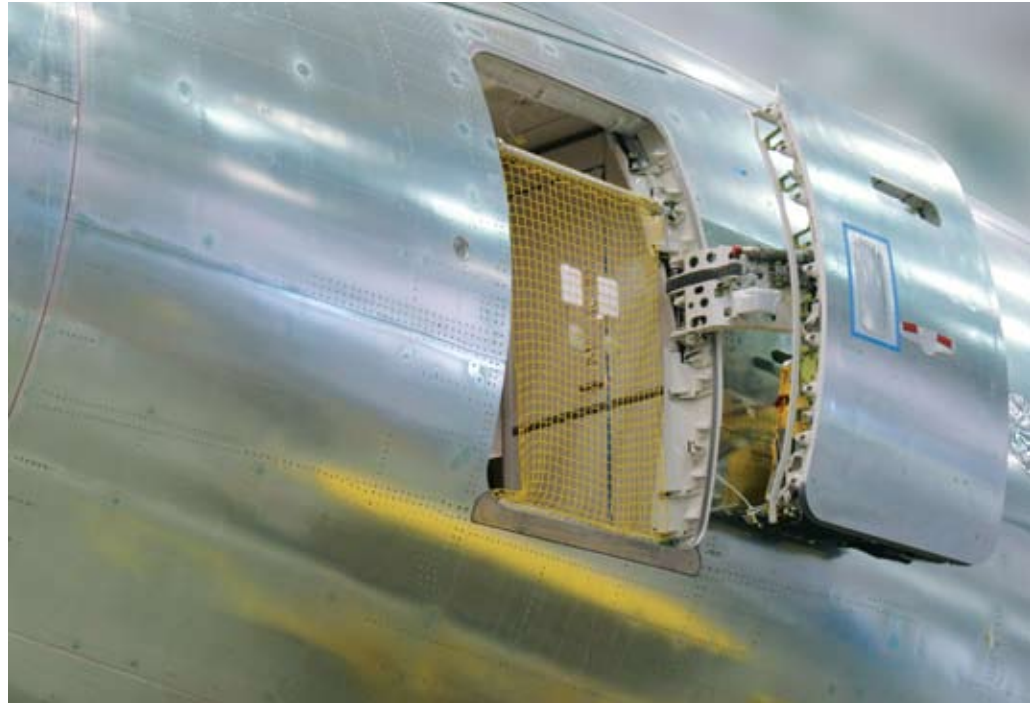
Door safety nets such as these are used on the 777 during production.

On occasions when doors are left open deliberately, such as to air out an airplane during cleaning, steps should be taken to block the door. Some operators use a simple strap to provide a visual signal that a door is open. However, the strap is not designed to stop a fall. Boeing recommends the use of a net any time a passenger or cargo door is left open and unprotected. This recommendation is also included in the 27th edition of the International Air Transport Association's *Airport Handling Manual*, which became effective Jan. 1, 2007. Boeing ground-support-equipment safety nets are available for use in cases in which the passenger door must be open or whenever a passenger door is being replaced.

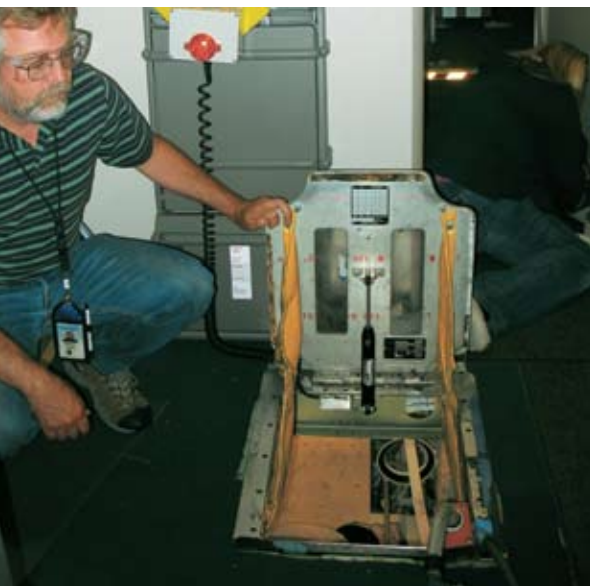
This hinged, self-closing E/E bay main deck access panel is used during 777 production. Note that the panel is connected to a red light, which flashes any time the access panel is open.

To help prevent accidents and injuries related to this panel, all 777s now being delivered have a hinged, self-closing access panel, and all 747s now being delivered have a safety net attached. For retrofitting purposes, all three airplane models have a hinged, self-closing access panel available, and the 747 and 767 models have a safety net available. Since 1982, Boeing has released a number of service bulletins related to methods available on the various models to block access to this panel. (Please refer to service bulletins Nos. 747-53-2434, 767-53-0092, and 777-53-0021.)
